South McQuesten River / Et'ó Nyäk Tagé cumulative impacts study

Project summary

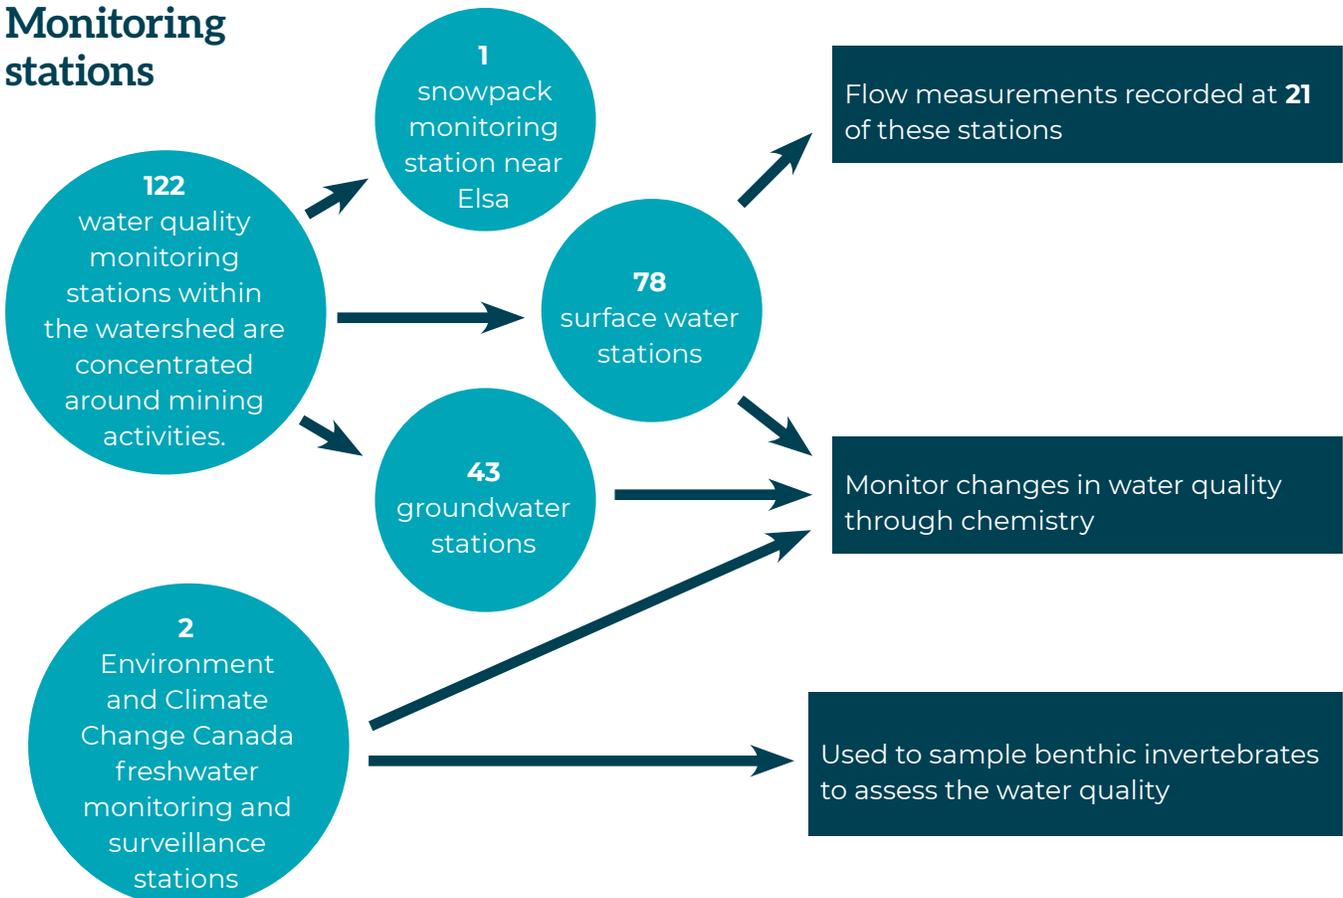
Monitoring stations

Water quality is monitored by various governments and organizations throughout the watershed to detect potential impacts associated with anthropogenic activities and climate change. A map showing all the monitoring stations is in the full report, available from open.yukon.ca/information/publications/plans-and-reports-water.

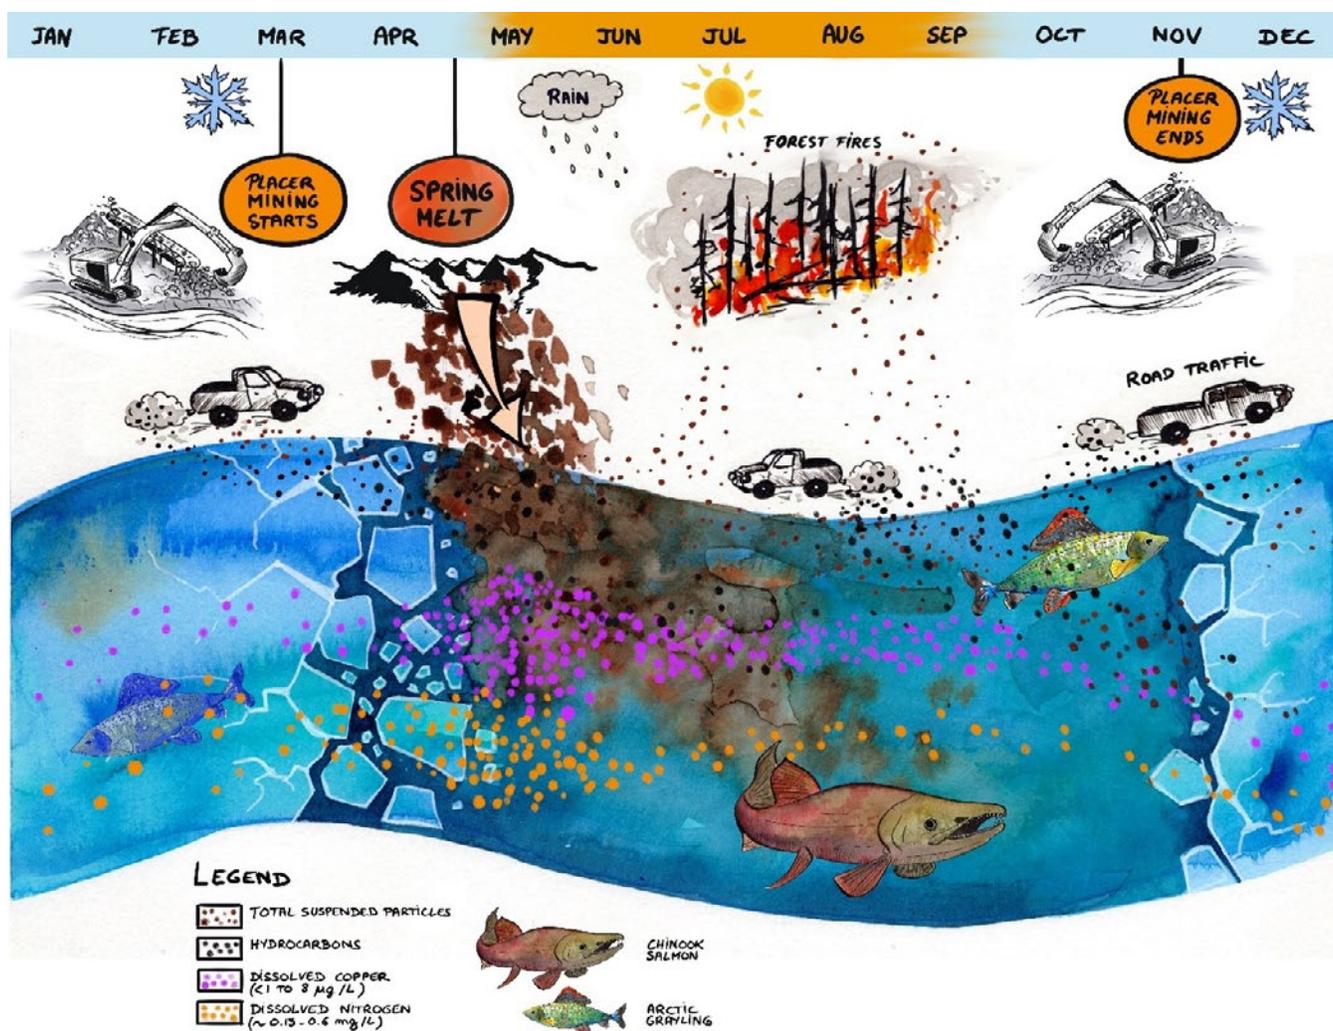
Multiple activities occur in the South McQuesten River watershed, including recreational and subsistence fishing, hunting, trapping, recreation, quartz mining and placer mining. Some of these activities, in addition to climate change, can contribute to impacting water quality. Mining can be a source of metals and suspended particles. Access roads adjacent or crossing a river can be a source of hydrocarbons and total suspended solids. Wildfires may result in an increase of nitrogen, organic carbon and total suspended solids to surface water. Generally speaking, the quality of the water changes over the seasons, over the years, and changes as the water flows through the watershed.

Illustration 1: Human impacts on the South McQuesten River throughout the year.

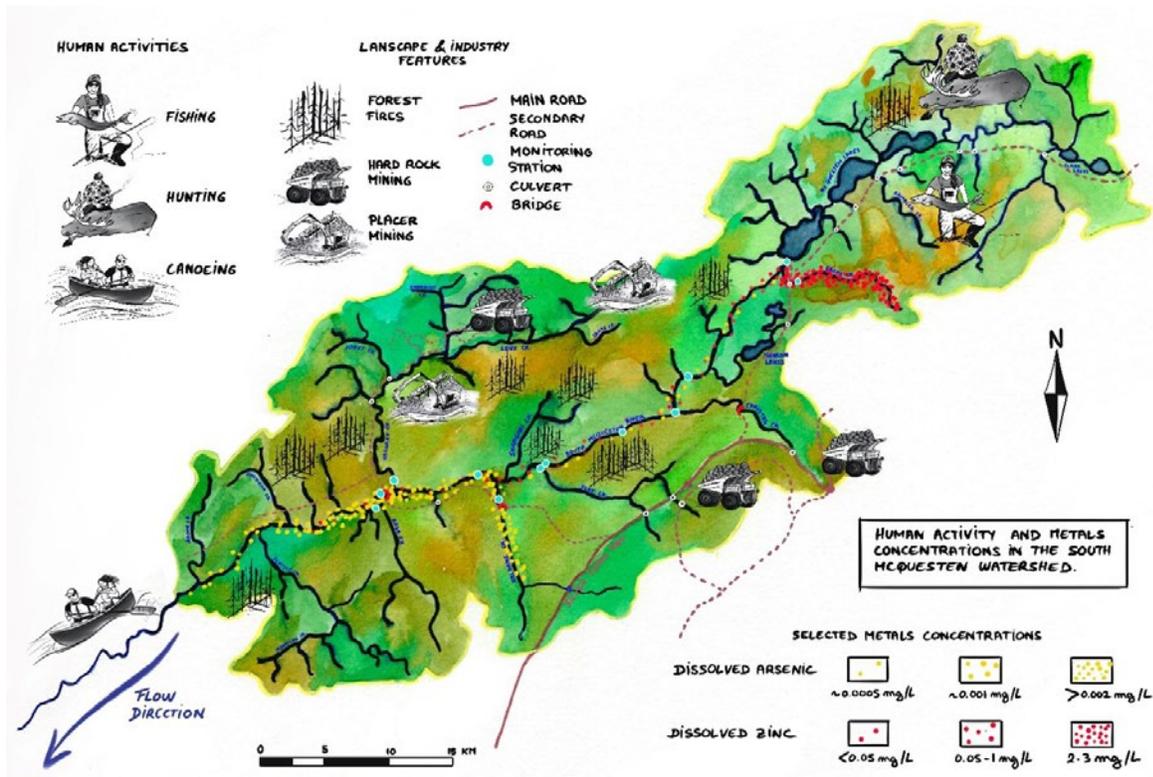
Water chemistry along the South McQuesten River reflects the influence from the tributaries and the environment as the river progresses downstream. An increase in aluminum, copper and zinc occurs downstream of Cache Creek, the most upstream tributary, where these parameters were the highest. Cadmium, copper and zinc concentrations decrease as the river progresses downstream due to dilution. Lead concentration was the highest downstream of Christal Creek and Flat Creek, then decrease as the river flows downstream. Arsenic increases as the river flows downstream, likely from contributions of Haldane and Haggart creeks.

Illustration 2: Human activities and metals concentration in the South McQuesten watershed.

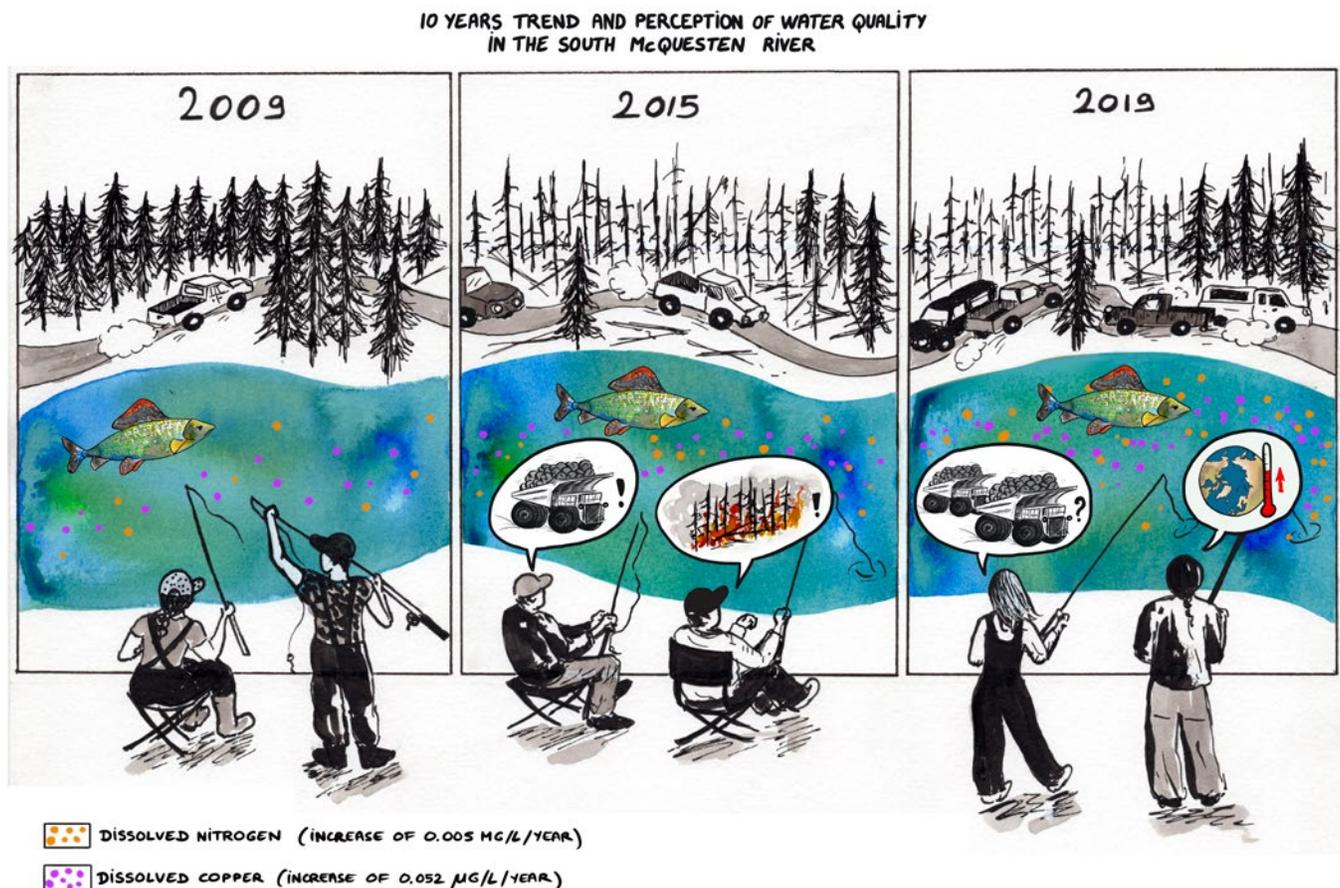
Environment and Climate Change Canada completed an evaluation of the trends of the water quality data over the last 10 years. The data came from the long-term monitoring station located in the South McQuesten river, upstream of Haggart Creek tributary. The analysis found some parameters increased in concentration (including turbidity, nitrogen and copper), while a decrease occurred for other parameters (including arsenic and pH).

Illustration 3: 10 years trend and perception of water quality in the South McQuesten River.

Changes observed in the water chemistry of the watershed is likely a result of multiple factors:

- ▶ climate change;
- ▶ development in the watershed; and
- ▶ an increase in surface runoff from:
 - ▶ burned and/or cleared vegetation,
 - ▶ roads, and
 - ▶ during spring melt.

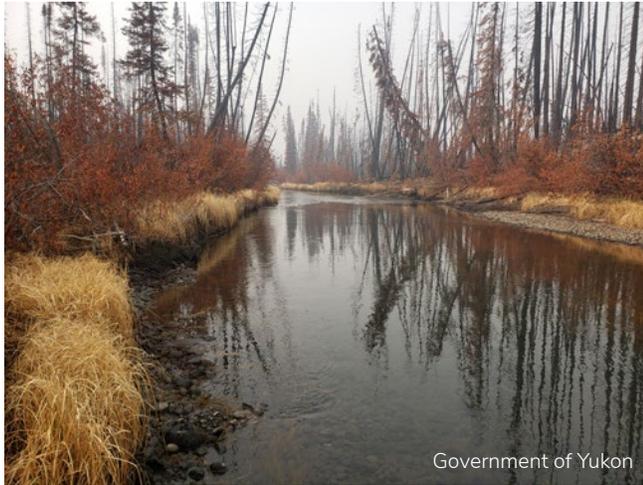
South McQuesten River in the fall at the long-term monitoring location.
