YUKON COLLEGE
Recommissioning Investigation

Prepared by:
Johnson Controls Canada L.P.
May 2020

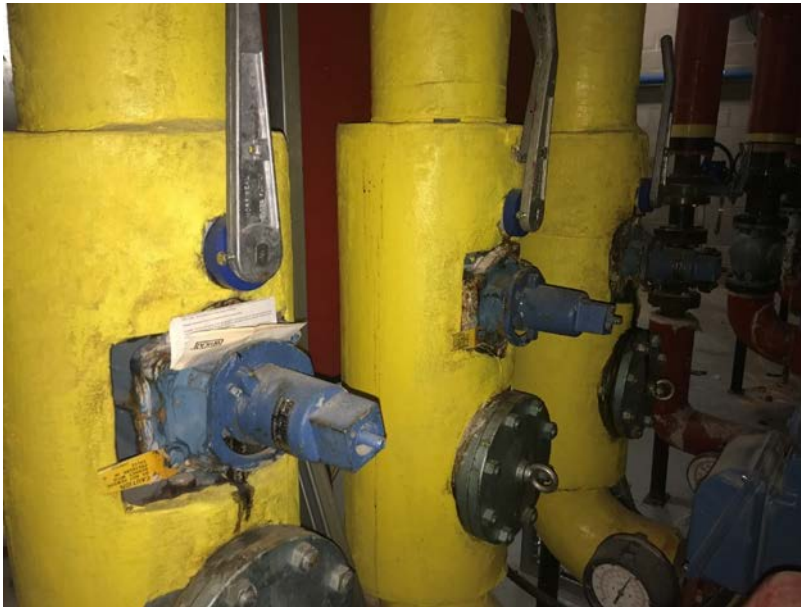
Figure 4: Secondary Pumps' Balancing Valves

Heating water throughout Yukon College is circulated through a series of constant flow primary, secondary, and tertiary loops. These loops are equipped with constant speed pumps and have their flow rates set with balancing valves. According to operations staff, these pumps have not been balanced since construction, and the balancing valves have been used for isolation due to passing manual isolation valves. This may cause the systems to be circulating more water than necessary. The balancing valves are currently fully open as shown in Figure 4.

We recommend installing variable speed drives (VSDs) on the secondary pumps and retrofitting some heating loads with 2-way valves. Per Figure 5, this uses less power than operating at full flow or reducing the flow by throttling valves.

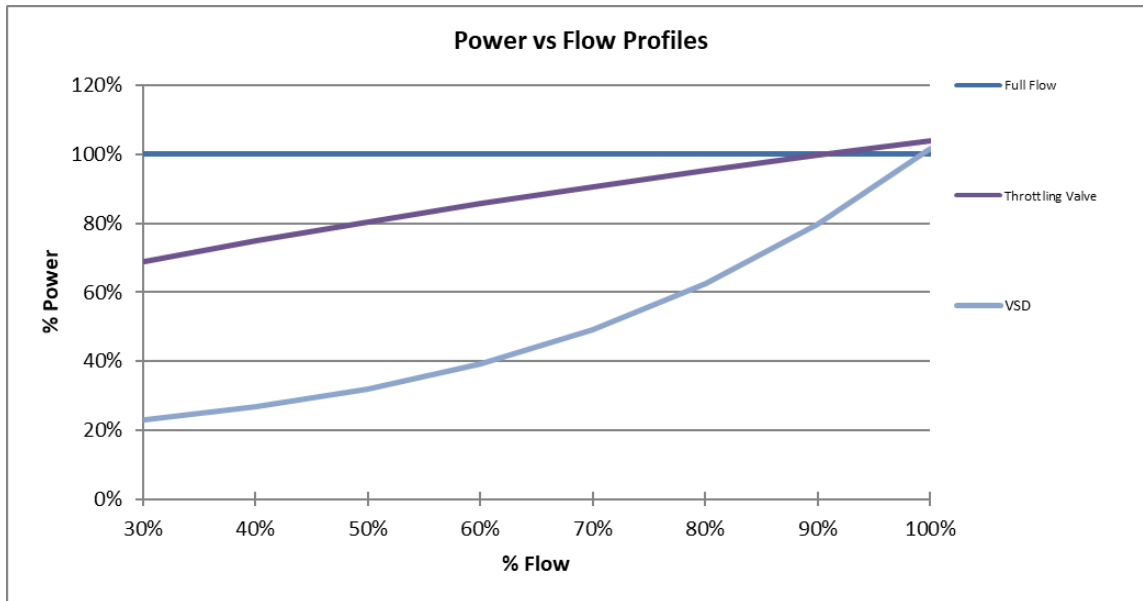
Figure 5: Power vs Flow Profiles for VSDs and Throttling Valves

Even for constant flow systems, there may be savings potential in balancing through variable speed drives instead of balancing valves. Typically, pumps are slightly oversized to ensure they can meet design conditions and are throttled with balancing valves. At high flow percentages, the power used by a VSD drops far faster than for a throttling valve, which means that at 80% of a pump’s design flow it will only use 50% power if equipped with a VSD, neglecting VFD and motor part-load inefficiencies, as shown in Figure 5.

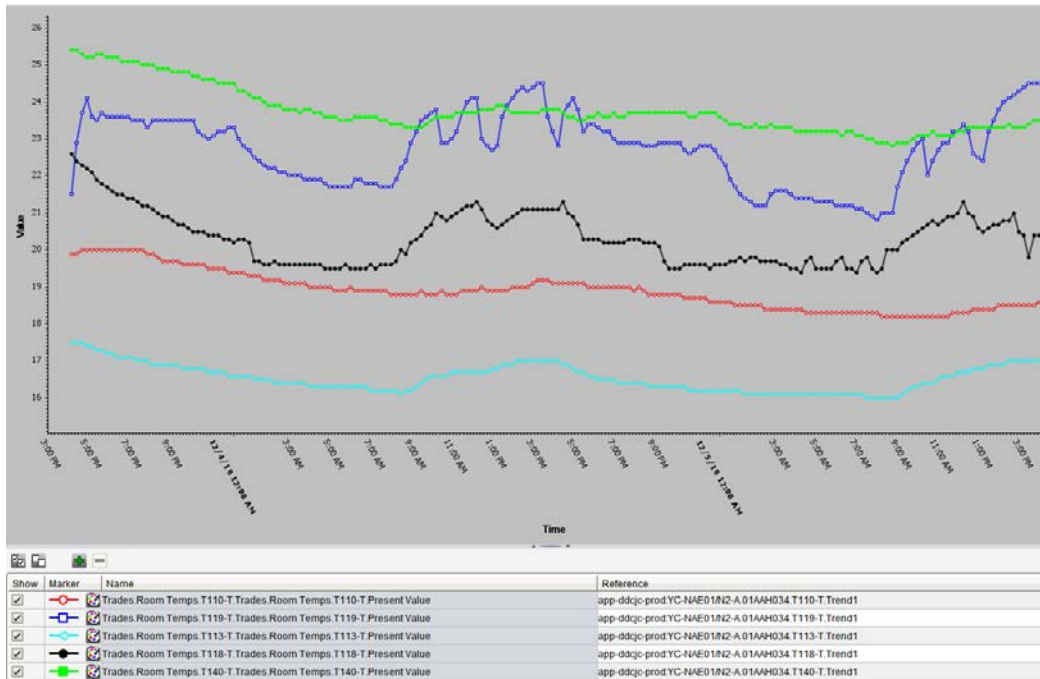
Figure 7: AHU-T5 Zone Temperature Trends

Most pneumatic controls at Yukon College have been integrated with the DDC system by installing transducers. However, radiators that are not tied to any FTU are still typically not tied to the DDC. Other rooms may return temperature readings to the DDC, but the radiators are not controlled, such as the AHU-T5 zones shown in Figure 7. Without full DDC integration, it is difficult to coordinate local controls with global building needs.

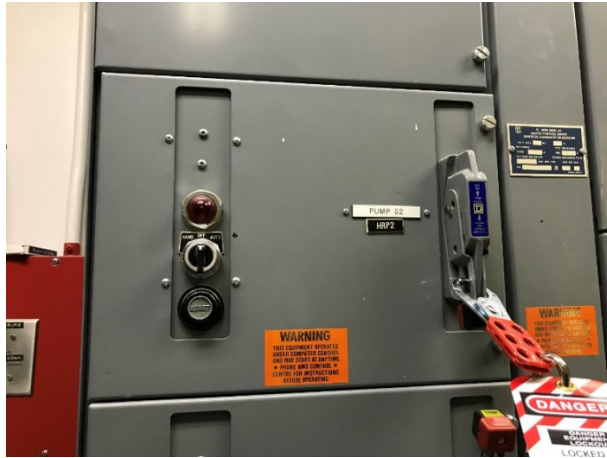
Figure 11: AHU-G1 Heat Recovery Circulation Pump G2 Lockout

The AHU-G1 glycol heat recovery coil circulation pump (Pump G2) was not running at the time of the site visits but was locked out by maintenance. At the time, the outdoor air temperature was around -10°C, suggesting heat recovery was desirable. Pump command and status are not shown in the DDC graphics. Trend data shows Pump G2 has not operated for over a year.

Service on Pump G2 should be completed and the pump should operate when heat recovery is beneficial. It should also be shown on the DDC graphics.

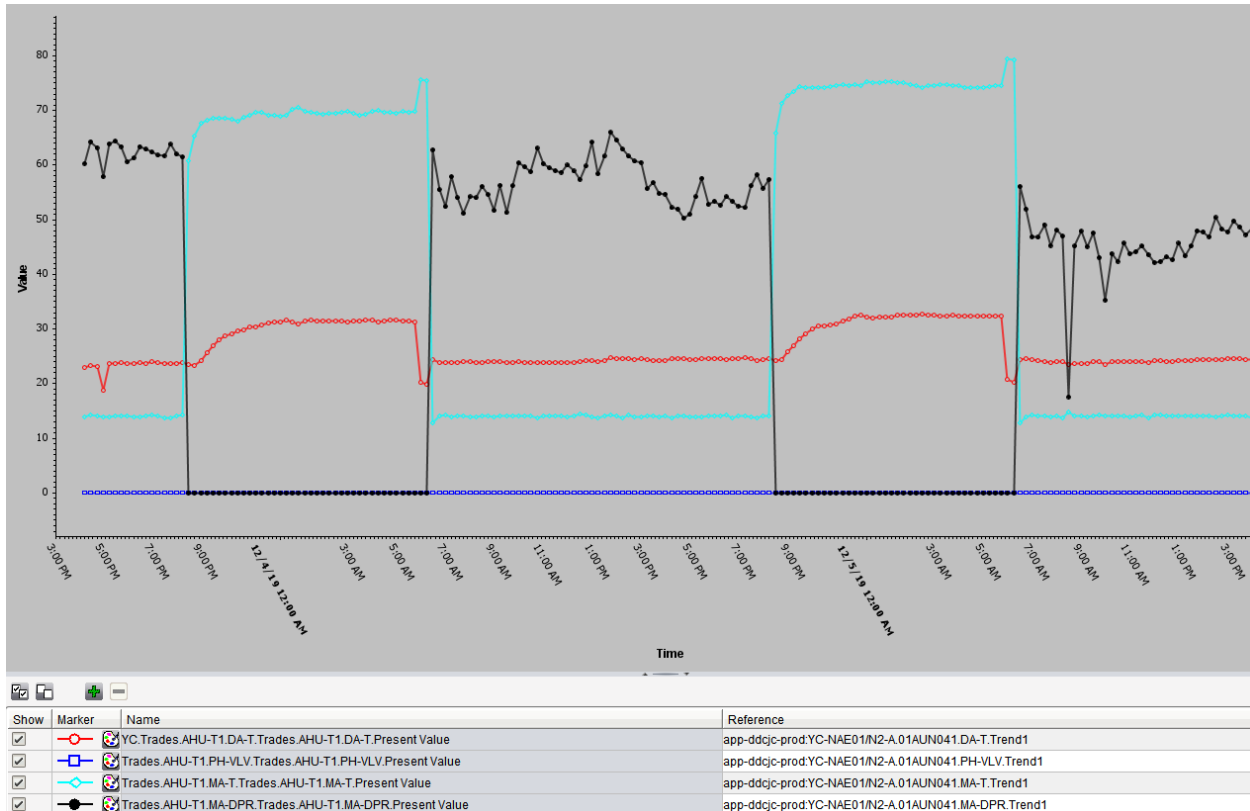
Figure 15: AHU-T1 Trends

AHU-T1's preheat valve is at 0% in Figure 15 (dark blue), but providing a lot of heat as evidenced by the high supply air temperature (red). The mixing damper (black) is modulating to maintain the supply air temperature setpoint, reaching 65% at times in cold winter weather. It is not clear if 0% represents the valve being fully open, or if the valve is passing. However, there is unnecessary simultaneous heating and cooling in both cases.

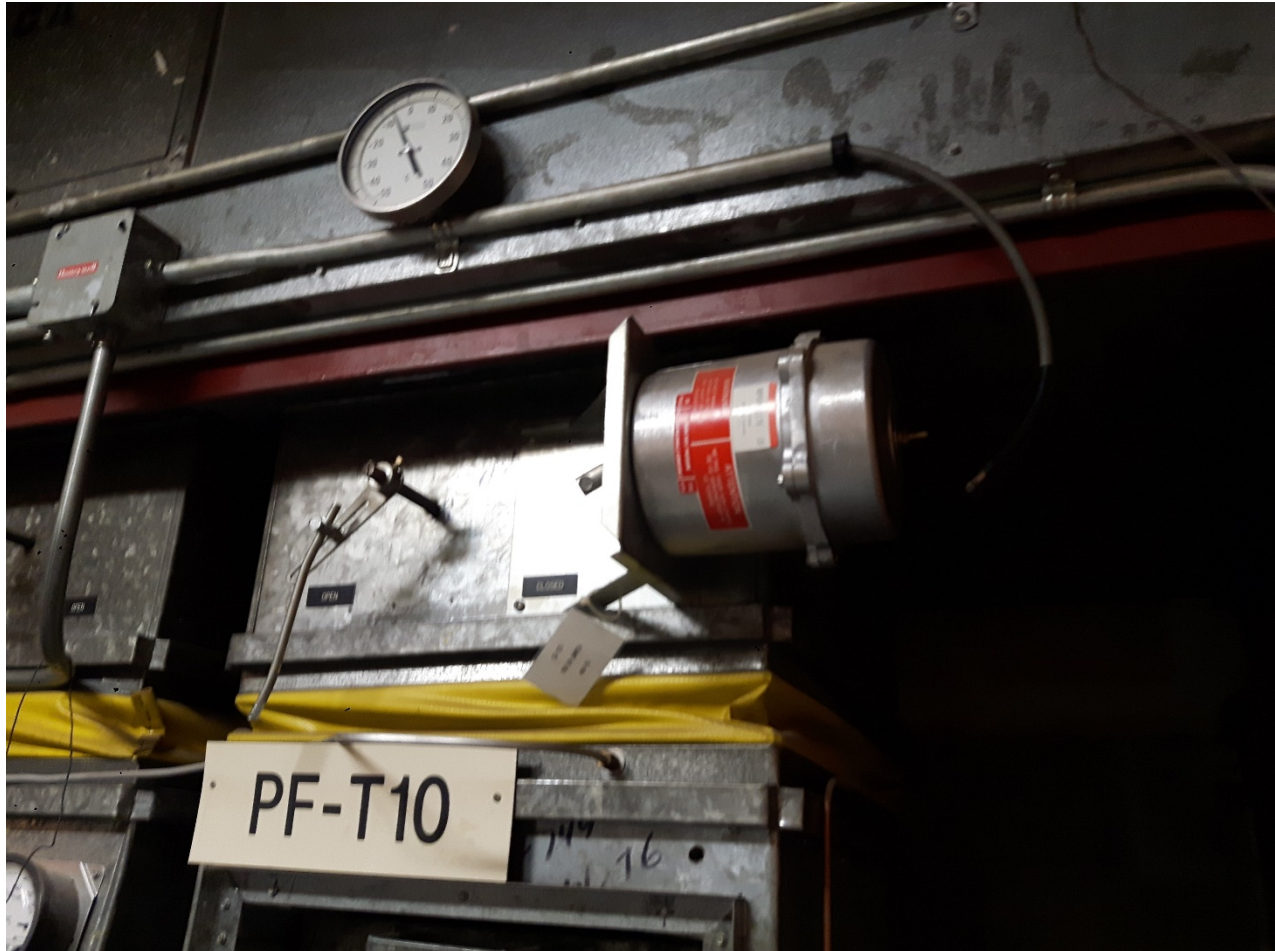
Figure 16: AHU-T6 Damper Actuator

DDC damper commands are not reflected in the field. According to the DDC, during the February 2020 site visit MAD was 100% (full return), relief was 10% open, and min OAD was 100% open. However, MAD was actually 0% (full relief), relief was 100% open, and min OAD was closed.

During the November 2019 site visit, the damper actuator was observed to be broken, as shown in Figure 16. The large labels throughout Yukon College, and particularly in the Trades Building mechanical rooms, are misleading.

AHU-T6's supply fan and dampers should be repaired and resume operating. Failed damper actuators should be replaced with electric actuators. All damper Electric Pneumatic Transducers (EPTs) should be replaced, or the actuators upgraded to electric. The controls should be recommissioned by a service technician.

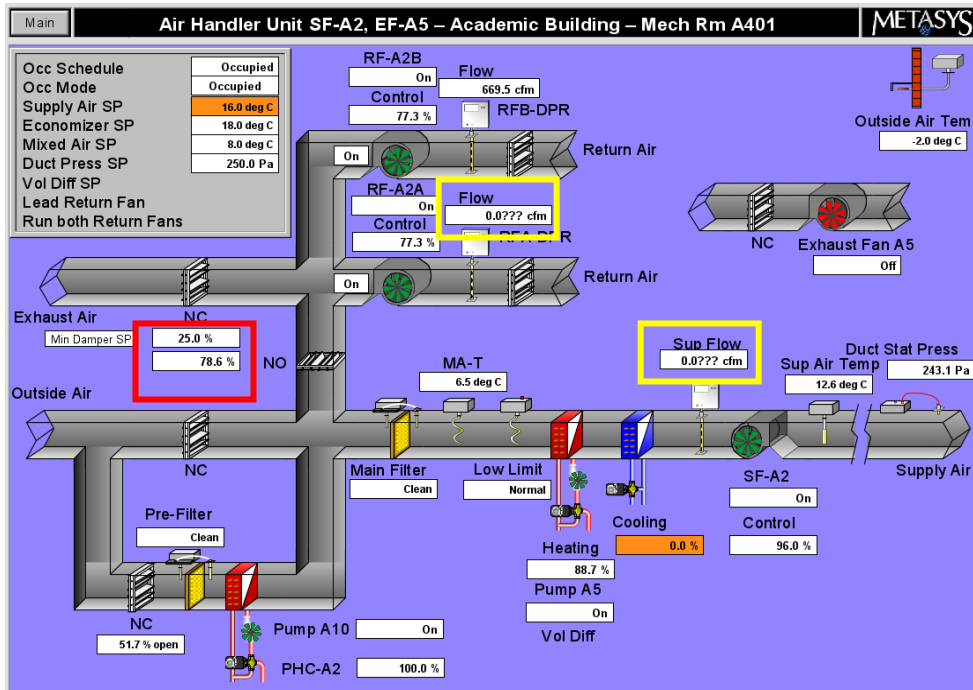
Figure 19: AHU-A2 DDC Graphic

For AHU-A2, this issue is causing the preheat and heating valves to open at the same time the mixing damper command exceeds the 25% minimum setting (red square Figure 19). Based on a 22°C return air temperature, the unit is operating with about 65% outdoor air. The result is an avoidable ventilation heating load.

AHU-A2's supply and return air flow sensors are not returning readings (yellow squares Figure 19). AHU-A3 has the same issue.

The air flow sensors are not used in the current control sequences. They should be removed from the graphics along with legacy control setpoints.

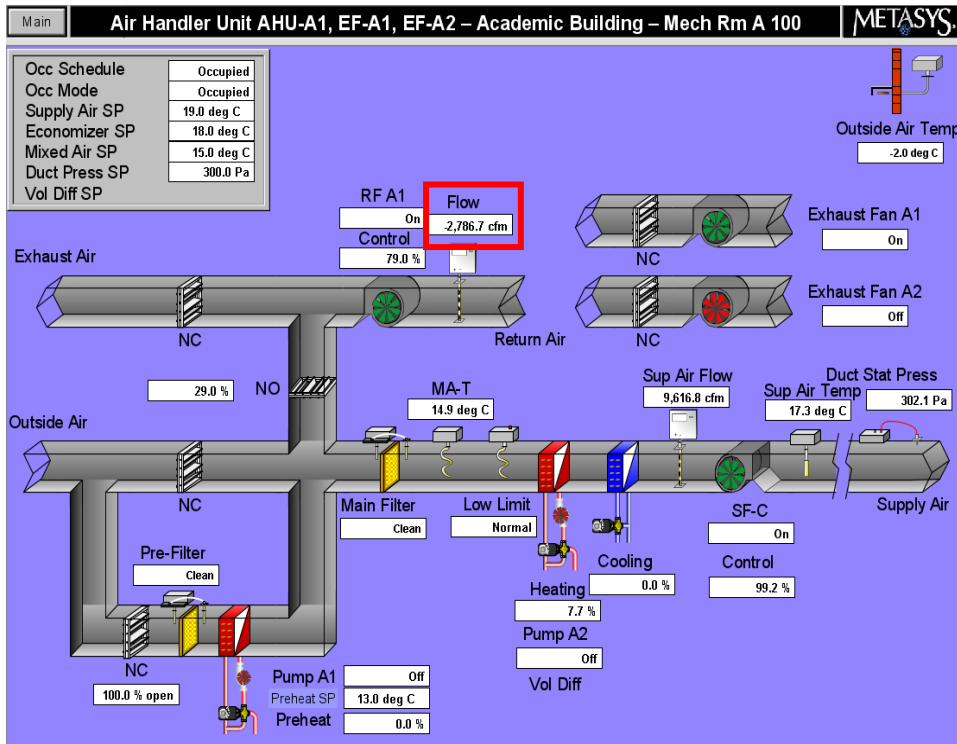
Figure 20: AHU-A1 DDC Graphic, Showing Defective RA-F Sensor

AHU-A1's return air flow sensor is reading negative despite the return fan operating.

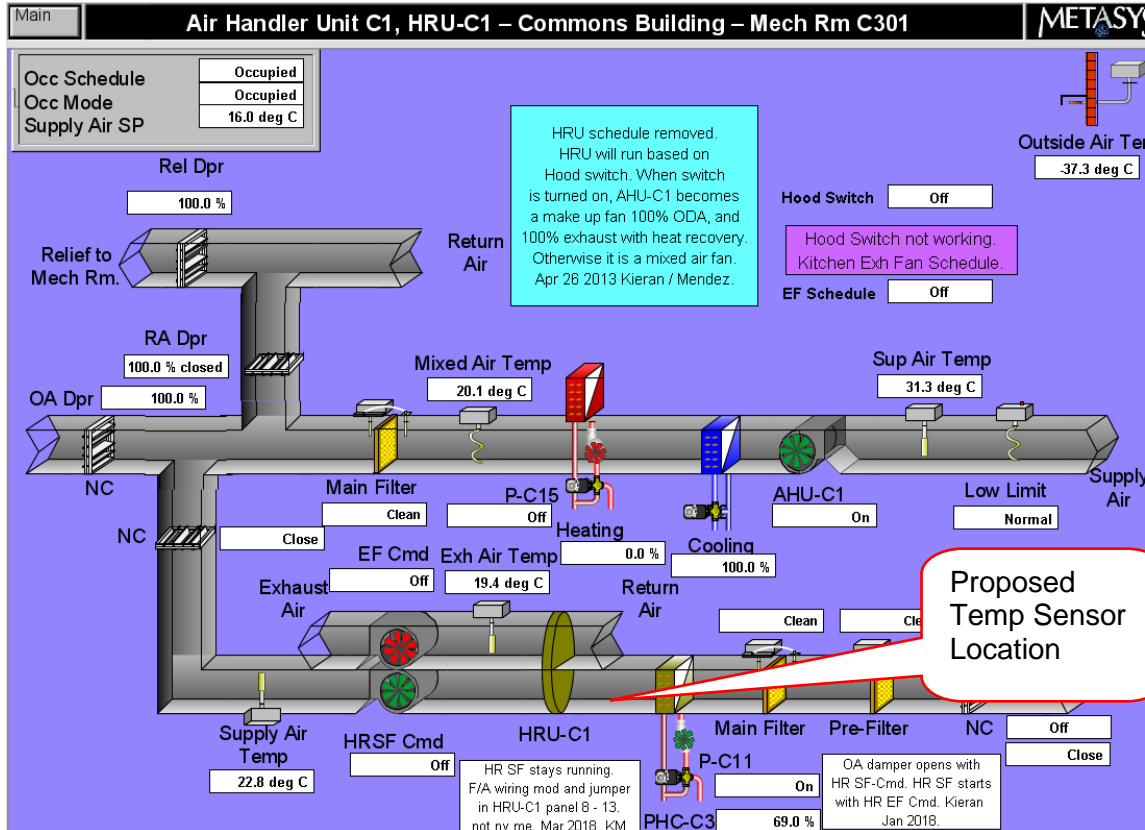
Figure 23: AHU-C1/HRU-C1 DDC Graphic

Heat recovery units HRU C1-C3 serve AHU C1-C3, as shown in Figure 23. Each HRU has an air-to-air heat exchanger (Figure 23 incorrectly shows them as heat wheels) equipped with face-and-bypass dampers. The face-and-bypass dampers are not tied to the DDC.

There is no temperature sensor between the preheat coil and air-to-air heat exchanger in each HRU. This makes it impossible to determine if the heat exchanger is effective or if the preheat valve is passing. We recommend installing a temperature sensor at the location shown in Figure 23 on HRU C1-C3.

The AHU-C1 supply air temperature setpoint is currently fixed at 16°C. This is likely too low in cold weather. If the zones were satisfied when Figure 23 was captured, then a supply air temperature of ~31°C may be suitable (though it should be too high for an interior kitchen). This low supply air temperature setpoint would cause simultaneous heating and cooling if achieved. It is recommended that a supply air temperature reset be implemented. Ideally, zone temperatures would be used. If these cannot be integrated with the DDC, an exhaust air temperature reset would be the next best possibility. Zones that are subsequently frequently too warm should be integrated with the DDC and used in the reset.

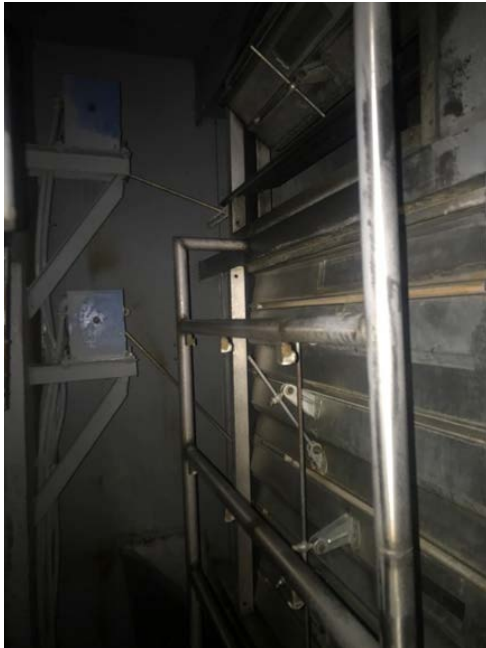
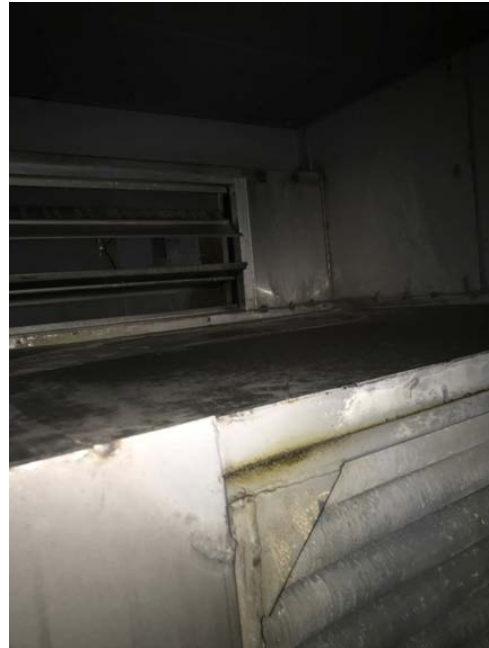
Figure 24: HRU-C1 Face-and-Bypass Dampers (from both sides)

The face-and-bypass damper actuators have failed on HRU C1-C3. HRU-C1 and HRU-C2 are stuck open on bypass, causing no heat recovery and very high energy use. HRU-C3's face-and-bypass dampers are closed, and its fans are blowing/sucking through closed dampers.

It is recommended that the face-and-bypass damper actuators on HRU C1-C3 be replaced and integrated with the DDC.

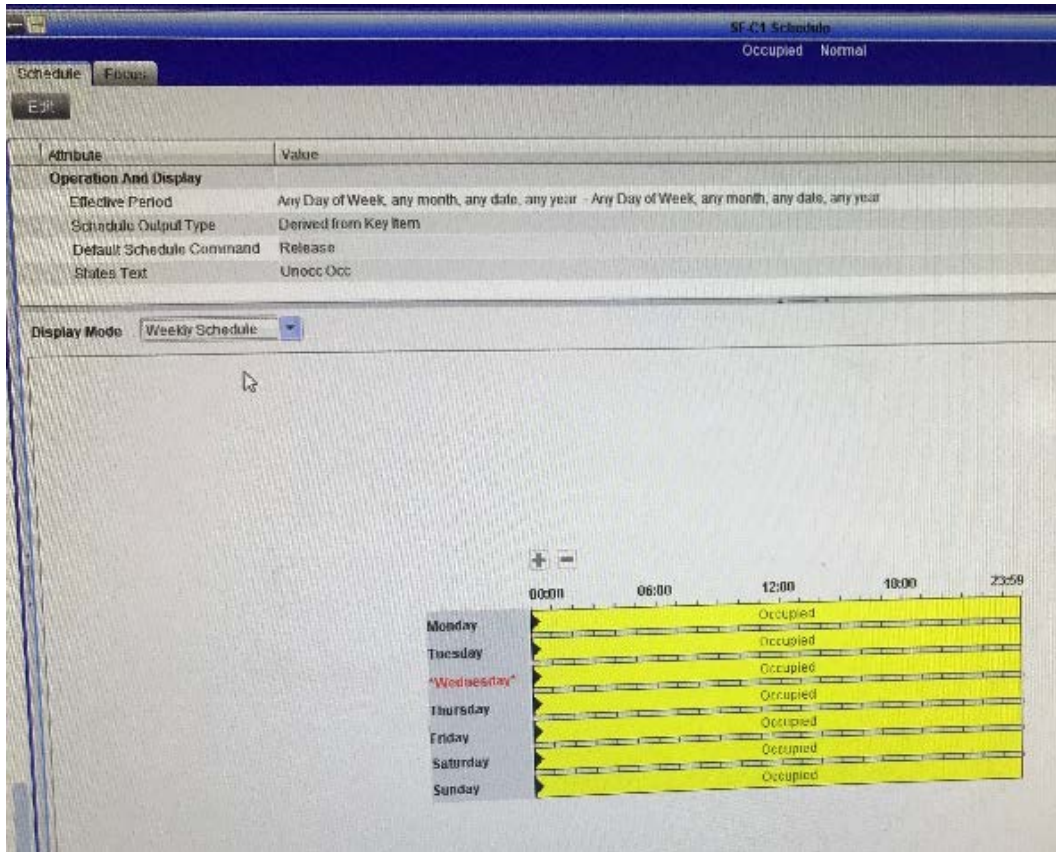
Figure 25: SF-C1 Schedule

AHU-C1, SF-C1, and SF-C2 serve the commons building. All three units operate 24/7. The college closes at midnight daily. It is recommended that these units shut down during the unoccupied hours, and the zones revert to night set back (NSB) temperature setpoints. If the units are required to operate to maintain NSBs or for morning warm-up, they should operate as mixed air units with minimum outdoor air of 0%.

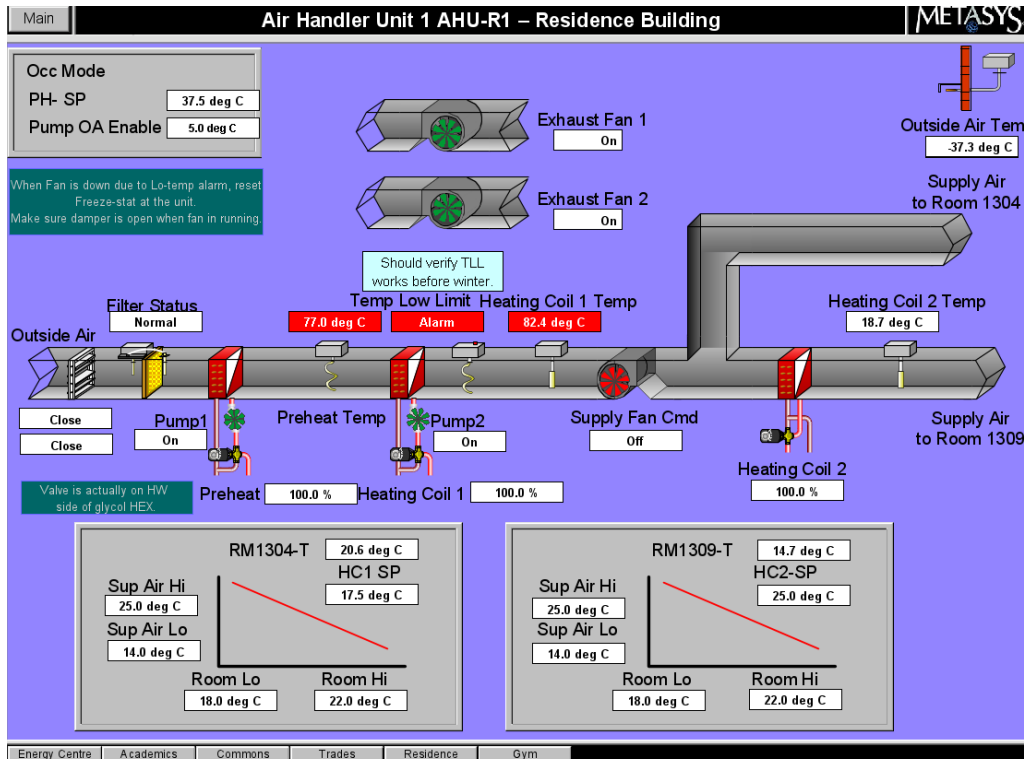
Figure 26: AHU-R1 DDC Graphic

The AHU-R1 supply air fan was tripped on low temperature when observed on the DDC system. This is likely due to poor heating valve control. A proportional low limit control loop should be implemented to ensure the preheat coil outlet temperature does not fall below setpoint.

If the above control fails to rectify the problem, it may be that the preheat valve is oversized. In this case it is recommended that it be replaced. If the existing valve is pneumatic, it should be replaced with an electronic valve.

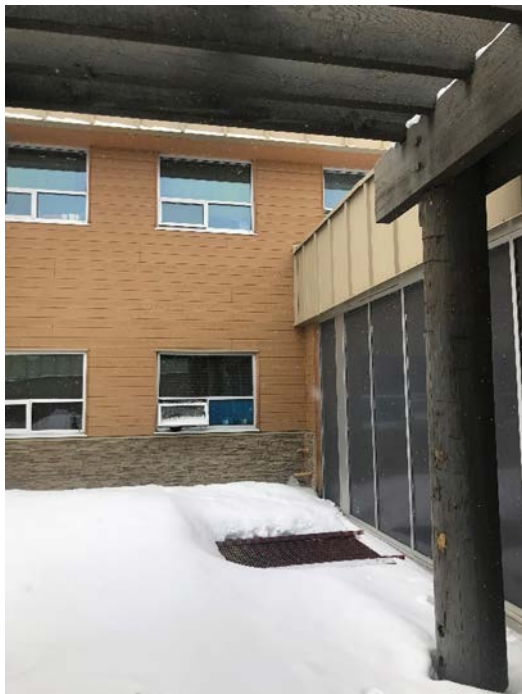
Figure 28: AHU-R1 Outdoor Air Intake

However, the exhaust fans are above the 2nd floor ceiling, and at opposite ends of the wing. The outdoor air intake is underground. This makes it uneconomical to install a heat recovery system. The location of the outdoor air intake is also unsuitable for installing a solar wall.
